MAIN STREET DAM
MA 00448

PHASE I INSPECTION REPORT
NATIONAL DAM INSPECTION PROGRAM

MAY 1979

Identification No.: MA 00448
Name of Dam: MAIN STREET DAM
Town: HUDSON
County and State: MIDDLESEX, MASSACHUSETTS
Stream: DANFORTH BROOK
Date of Inspection: 8 NOVEMBER 1978

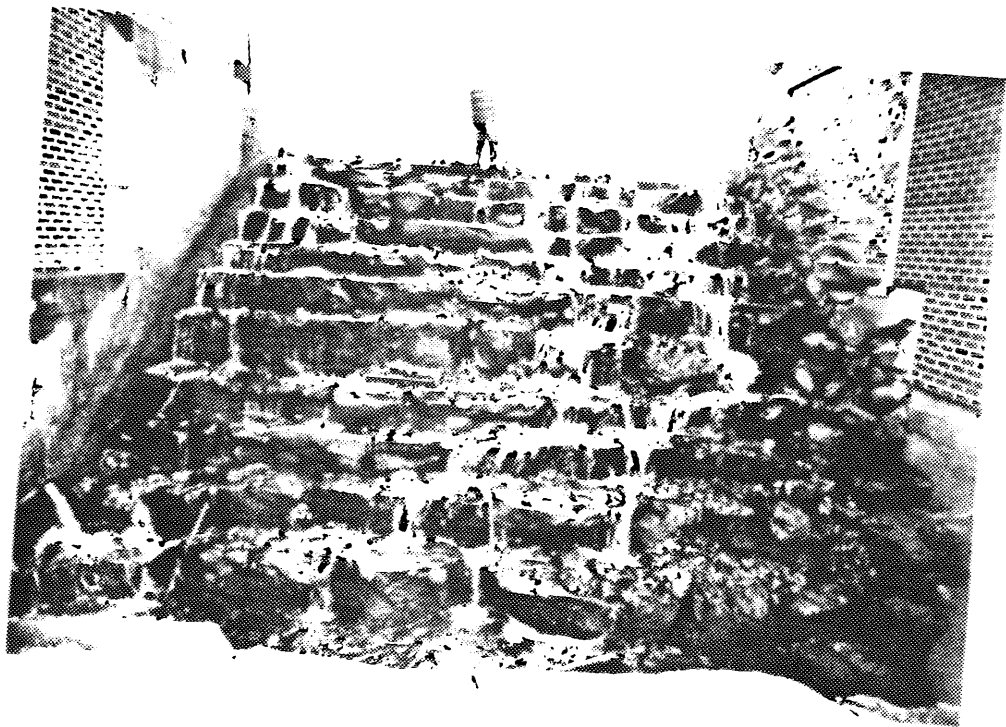
1. Overview of spillway from downstream parking lot.

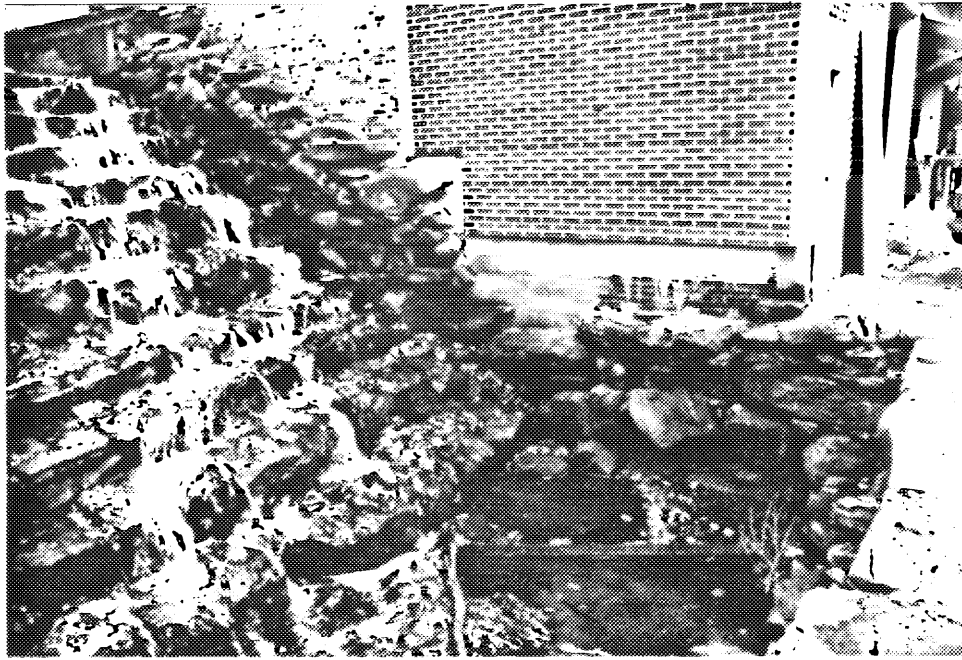
2. View of left side of spillway from parking lot.

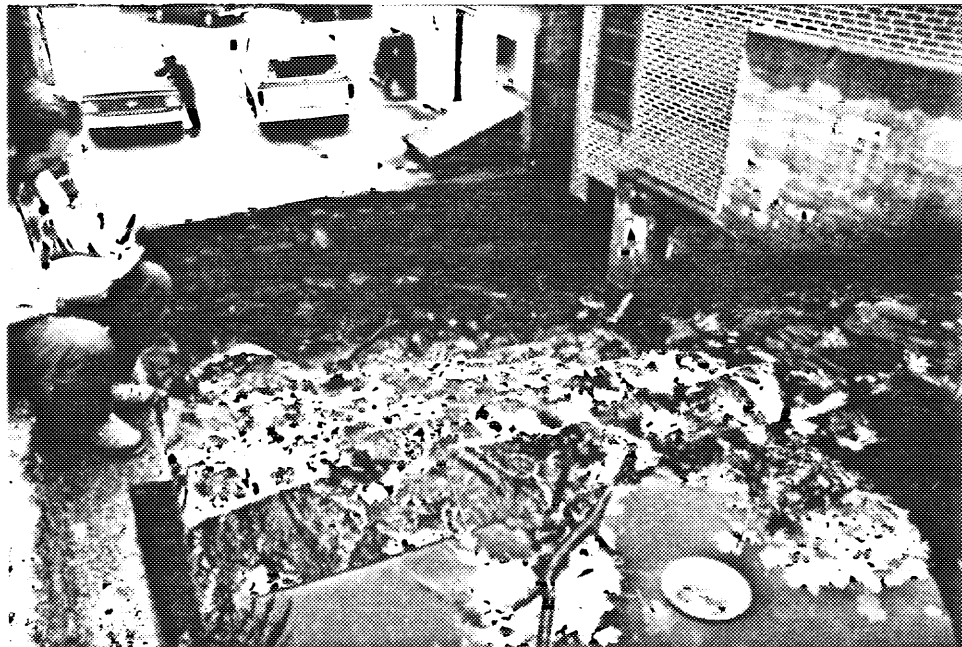
3. View of spillway and parking lot downstream.

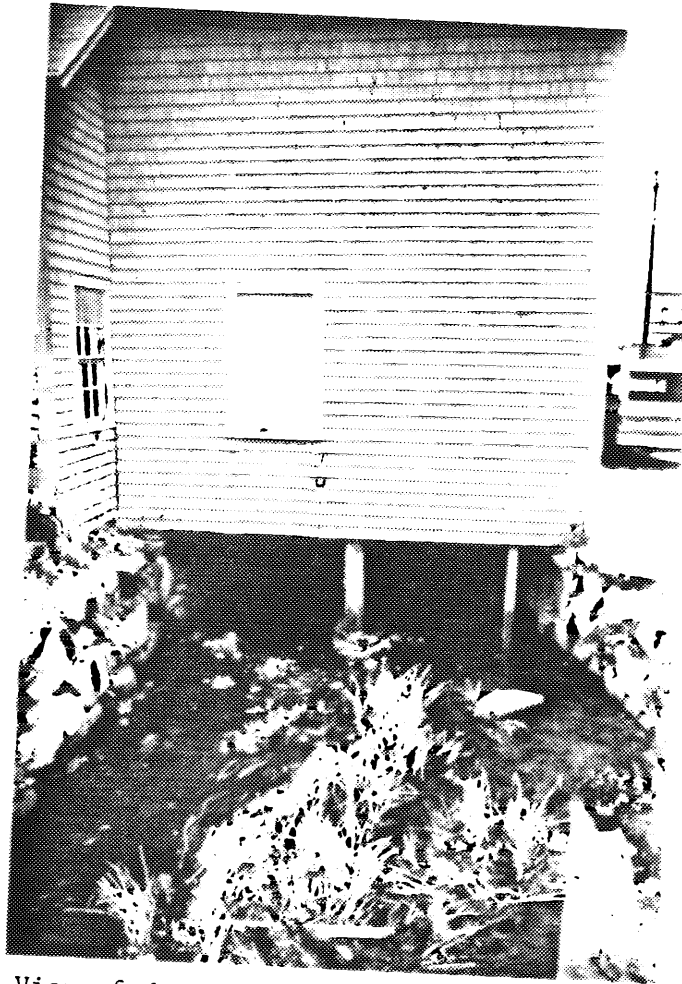
The spillway is in good condition with no noticeable deficiencies. There is seepage present at the base of the north and west stone walls of the discharge channel beneath the building on the right side of the spillway. Because the source of this flow is unknown as well as the limited spillway capacity and need for maintenance, the dam is considered to be in only fair condition.

4. View of downstream channel and culvert under building.

1. An investigation to verify the source of the water flow that is entering the discharge channel through the north and west stone masonry walls beneath the building to the right of the spillway. This can apparently be accomplished from the crawl space under the building. If all or part of this flow originates at the downstream stone masonry wall of the right embankment the source should be examined for evidence of piping or soil erosion, and the flow should be regularly monitored to determine if conditions are changing with time. If soil movement or changing conditions become evident, corrective action should be taken.

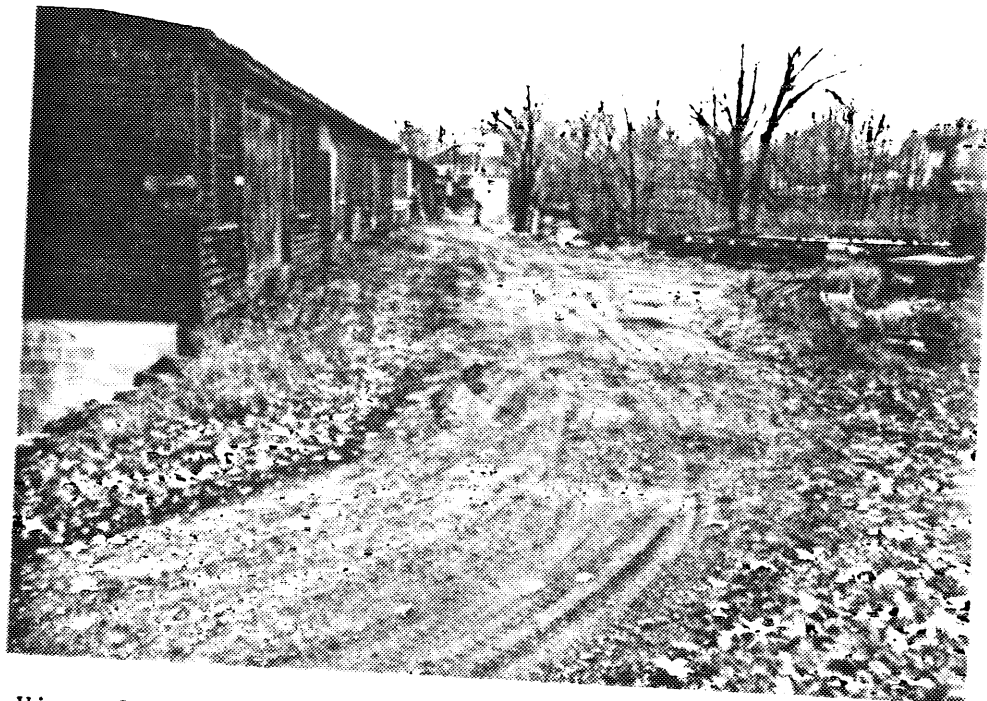
5. View of embankment from left abutment. Note upper stories of buildings constructed at downstream edge of crest.

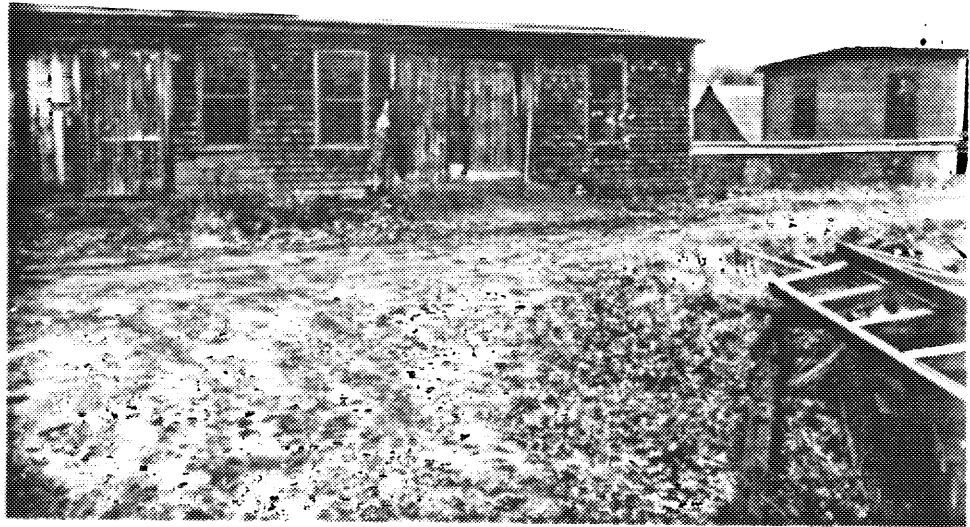
6. Upper story of building constructed at downstream edge of dam crest.
